A Naval Safety Center Publication

approach

DECEMBER 1973 THE NAVAL AVIATION SAFETY REVIEW

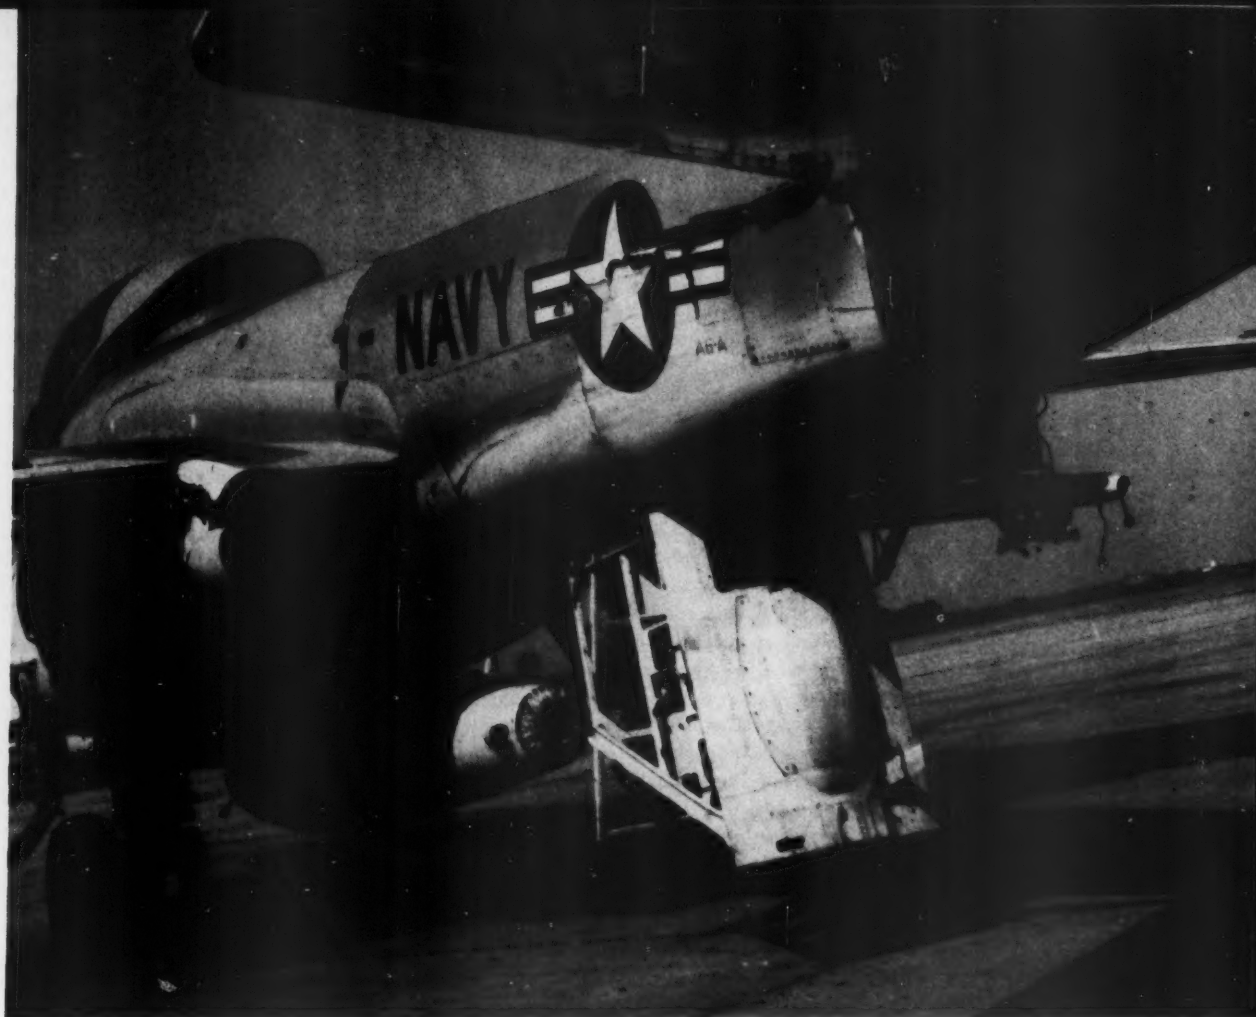
Unknown to the crew, the port fuselage sustained five severed bulkhead frame assemblies between stations 450-519 and a hole in the fuselage side panel. The port tailpipe and engine shroud sustained skin damage (see photos).

- That a visual check of aircraft and ordnance integrity be performed by wingmen or other aircraft immediately following the jettisoning of droptanks and inadvertent jettisoning of any stores or ordnance. The failure of the crew to notify the flight leader and request a visual ordnance/airframe integrity check in this mishap might have resulted in the loss of an aircraft and crew due to the additional stress imposed on damaged structural assemblies during the dive-bombing. If unable to obtain a visual integrity check of the aircraft subsequent to droptank jettison, it is recommended the flight be aborted immediately to preclude operating an aircraft with possible undetected damage. ◀
